# Property Condition Report

**Property Address:**  
**1234 Any St.**  
**Knoxville TN 37918**

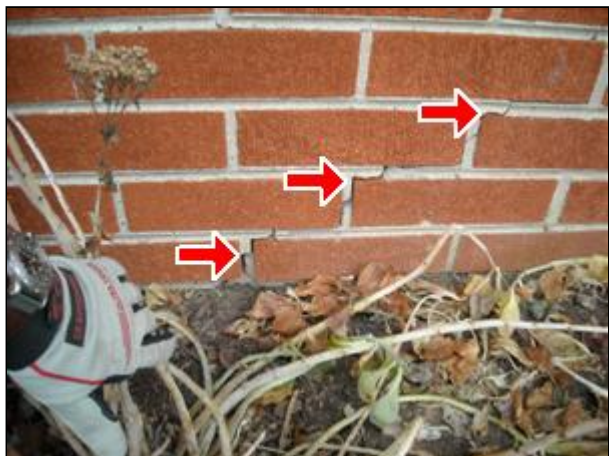
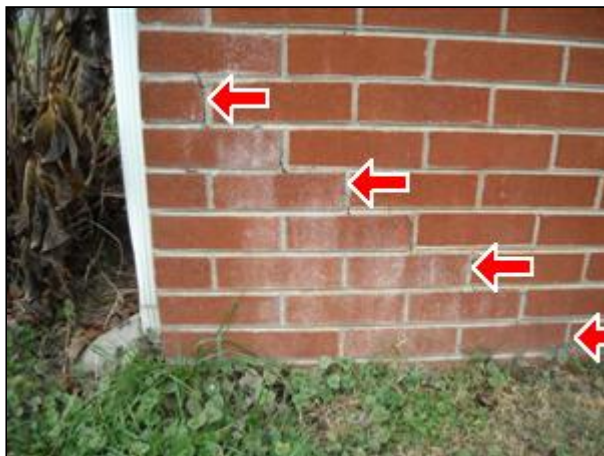
1.0 The brick exterior walls had stepped cracking visible in the mortar joints. It is recommended that these cracks be patched with an appropriate material to avoid continued damage from freezing moisture and monitor for future cracking.

This cracking does not appear significant at this time.

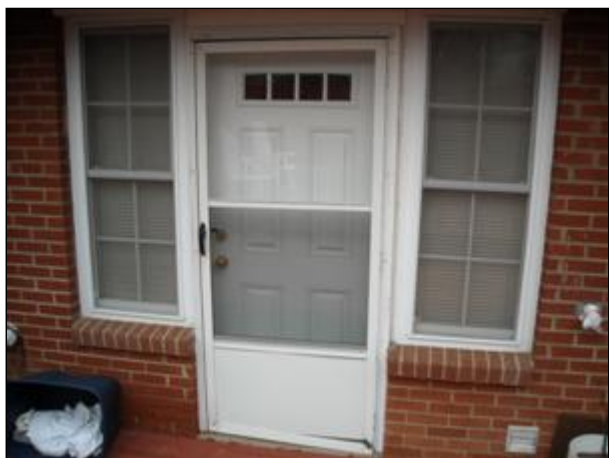
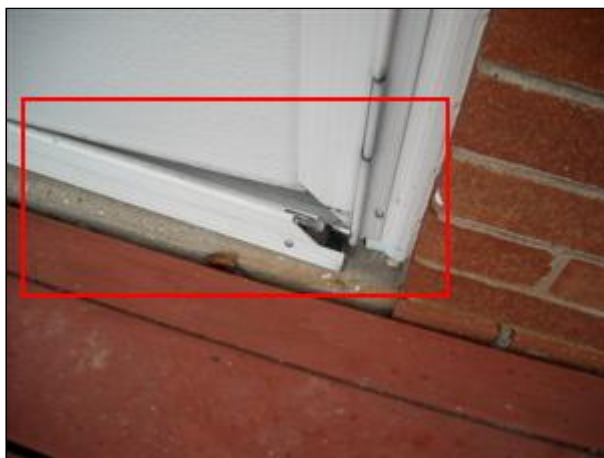
🔧 1.1 The storm door at the back of the home has a damaged trim piece at the bottom. Recommend repair.

The storm door at the back of the home has a damaged trim piece at the bottom. Recommend repair.

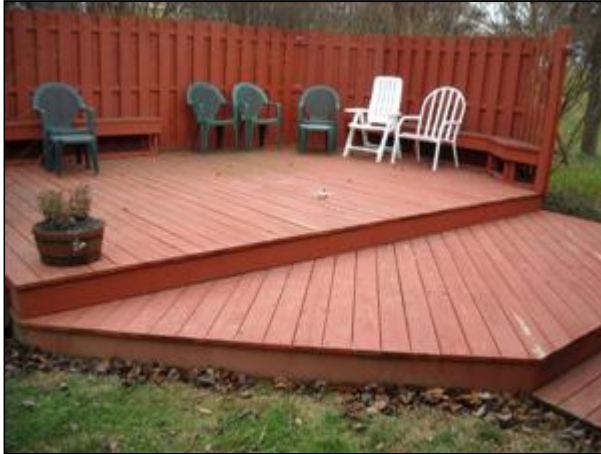
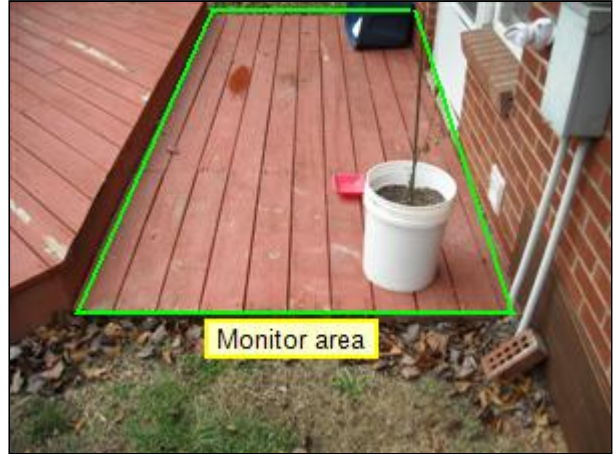
1.3 Wood framing members in contact and/or close to contact with the soil will be prone to wood rot/decay. It is highly recommend these areas be monitored for future damage.

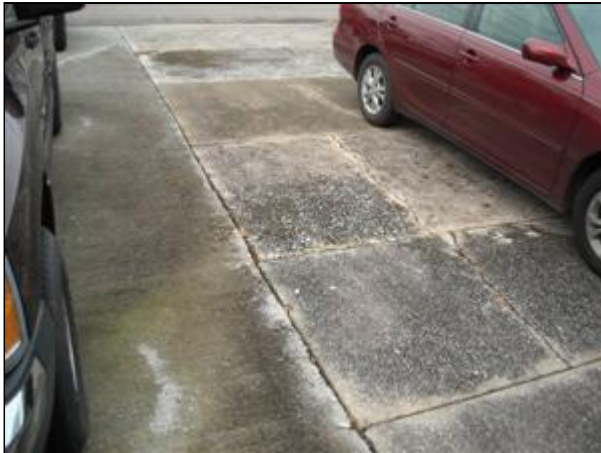
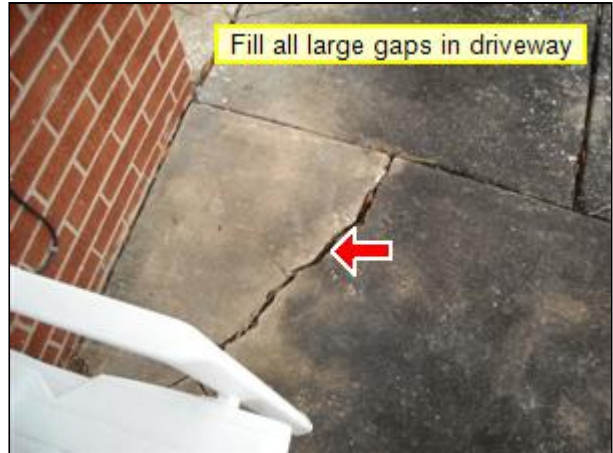
1.4 Significant cracks (1/4 in. or larger) visible in the driveway at the time of the inspection should be filled with an appropriate sealant to avoid continued damage to the driveway surface from freezing moisture.

Significant cracks (1/4 in. or larger) visible in the driveway at the time of the inspection should be filled with an appropriate sealant to avoid continued damage to the driveway surface from freezing moisture.

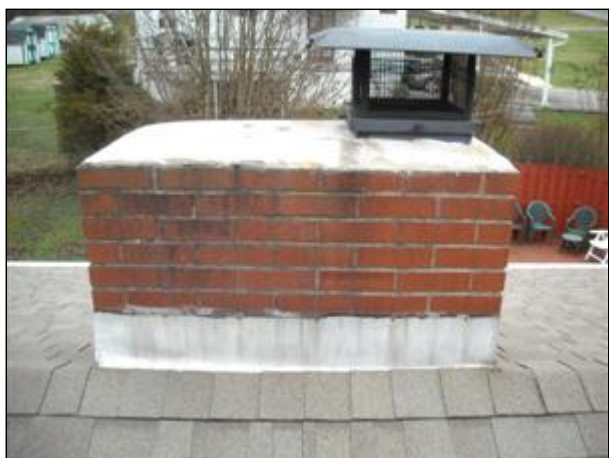
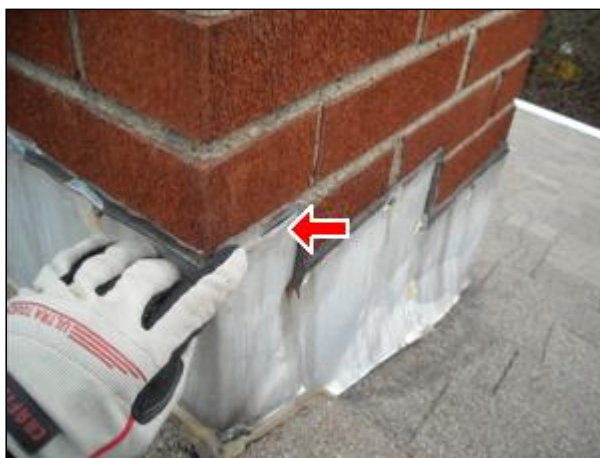
2.0 The flashing around the chimney that penetrates the roof is reliant upon a sealant to prevent moisture intrusion of the roof structure. Sealants eventually dry, shrink, and crack and can allow moisture intrusion of the roof assembly. You should be diligent in maintaining sealants protecting the chimney/roof penetration.

One small area needs sealant where flashing is pulling away from the brick chimney. (Picture 2)

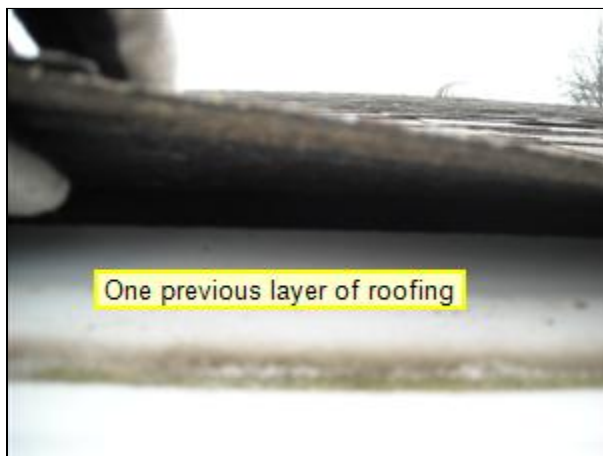
2.1 Item 1(Picture)

2.1 The 30 year "dimensional" or "architectural" composition shingle roof appears to be in satisfactory condition. I did observe at least one previous layer of roofing installed. It is recommended that both layers be taken off when a new roof is installed in the future.

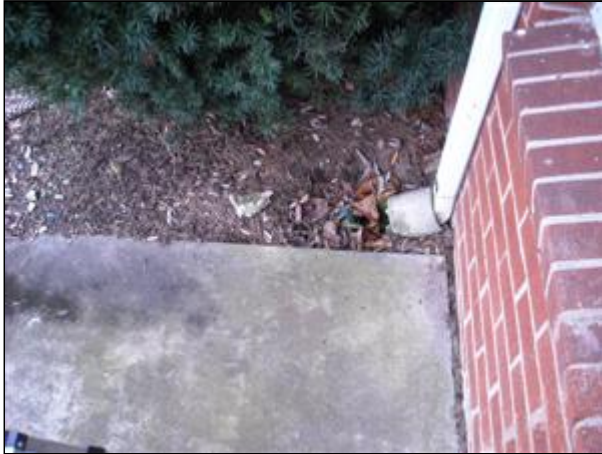
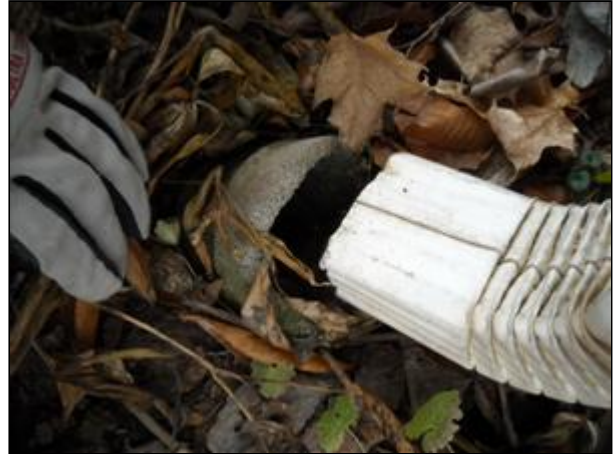
🔧 2.3 The downspout needs an extension/buried drain line to carry water away from the home at the front, rear and sides of home. Recommend installing black corrugated drain lines to divert water away from the structure.

The downspout needs an extension/buried drain line to carry water away from the home at the front, rear and sides of home. Recommend installing black corrugated drain lines to divert water away from the structure.

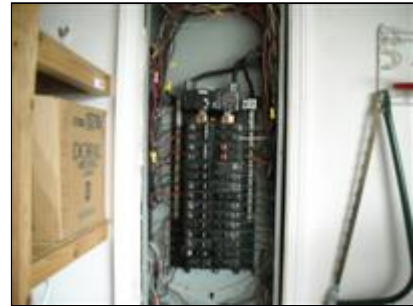
Panel cover off

🔧 (3) Gaps in the dead front cover of the main electrical service panel may allow a person to come into contact with energized electrical components. This condition is a potential shock/electrocution hazard.

It appears the trim around the panel is holding the cover off the wall. It is recommend this trim be removed, so that the panel cover will fit properly. Also, new, shorter screws will need to be used after removing trim.

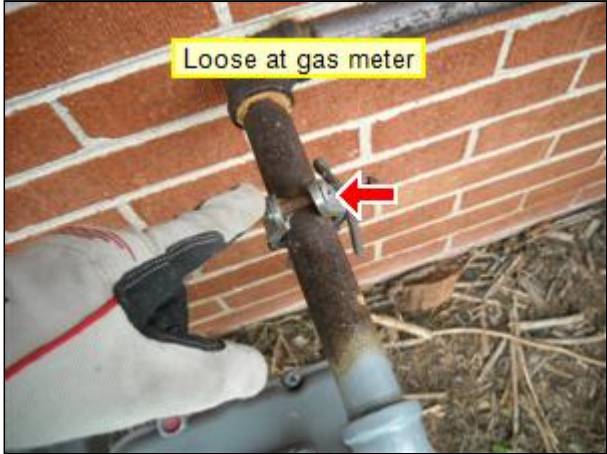
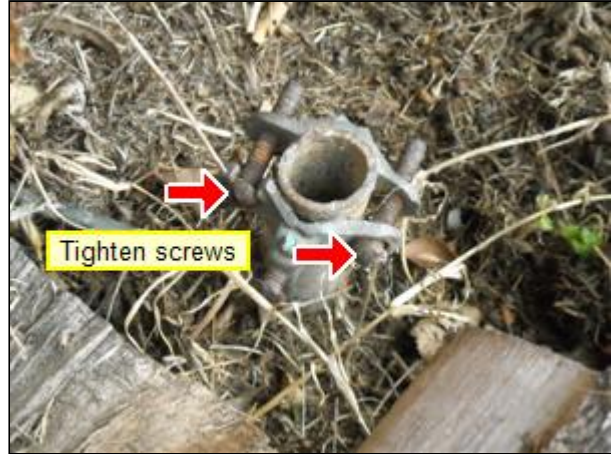
🔧 4.1 (1) Both grounding clamps are loose at the gas meter and main grounding rod at the exterior of the home. Proper grounding should be maintained throughout the electrical system. Recommend tightening these clamps.

(1) Both grounding clamps are loose at the gas meter and main grounding rod at the exterior of the home. Proper grounding should be maintained throughout the electrical system. Recommend tightening these clamps.

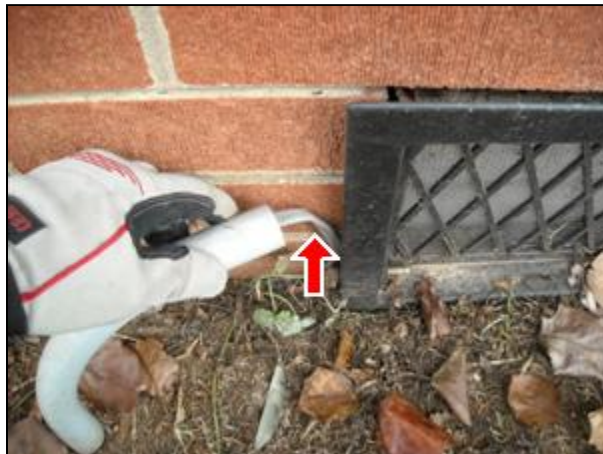
4.3 Item 1(Picture)

🔧 4.3 (1) I observed exposed wiring on the left exterior wall of the home. All wiring done on the exterior should be completely sealed in conduit to protect from damage and moisture.

- 🔧 (1) I observed exposed wiring on the left exterior wall of the home. All wiring done on the exterior should be completely sealed in conduit to protect from damage and moisture.
- 🔧 (2) Energized electrical splices not contained within a junction box and exposed to touch were visible in the attic at the time of the inspection. Electrical splices should be contained within an approved junction box with a cover plate installed. This condition is a shock/electrocution and potential fire hazard and should be corrected by a qualified electrical contractor.
- 🔧 (3) Frayed/damaged wiring was observed in the attic near the hatch.
- 🔧 (4) Although the 3-prong outlets installed in this home typically indicate a home with grounded branch wiring, this home had no grounding system installed to protect devices such as switches and electrical outlets.

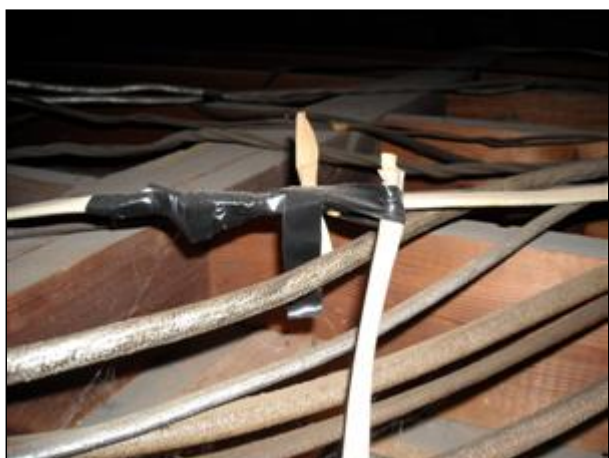
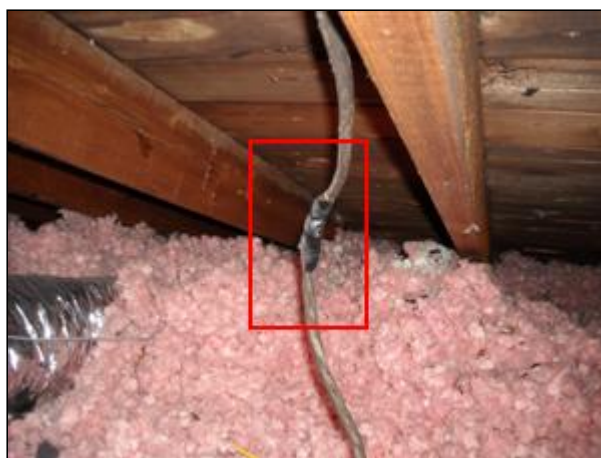
🔧 (2) Energized electrical splices not contained within a junction box and exposed to touch were visible in the attic at the time of the inspection. Electrical splices should be contained within an approved junction box with a cover plate installed. This condition is a shock/electrocution and potential fire hazard and should be corrected by a qualified electrical contractor.

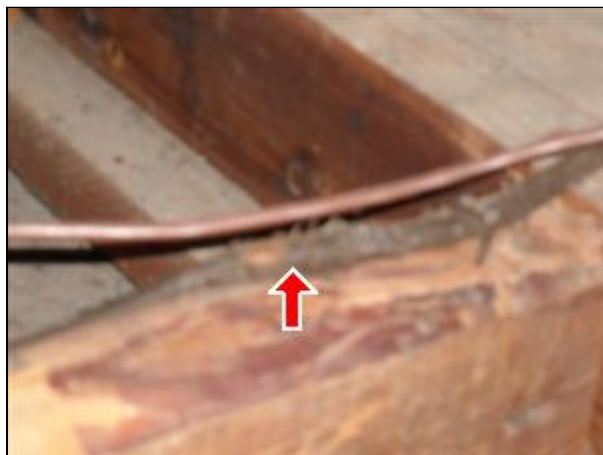
4.3 Item 4(Picture)

🔧 (3) Frayed/damaged wiring was observed in the attic near the hatch.

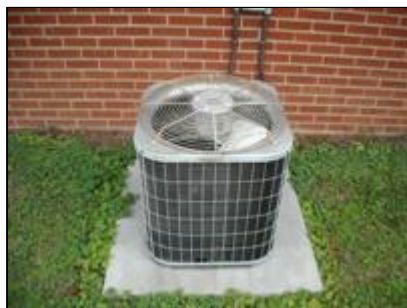
A/C Compressor

(2) The air conditioning system was a split system in which the cabinet housing the compressor, cooling fan and condensing coils was located physically apart from the evaporator coils. As is typical with split systems, the compressor/condenser cabinet was located at the home's exterior so that the heat collected inside the home could be released to the outside air. Evaporator coils designed to collect heat from the home interior were located inside a duct at the furnace.

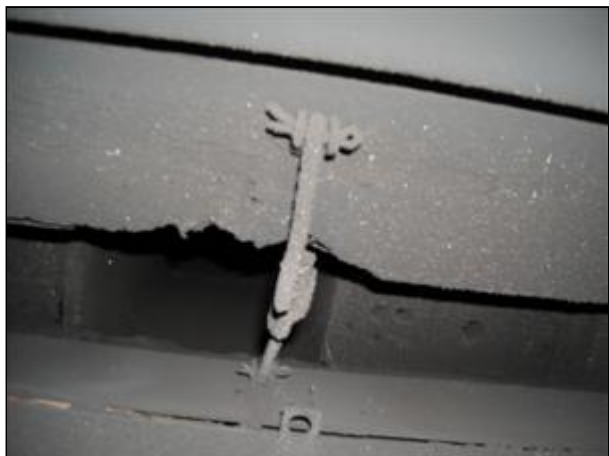
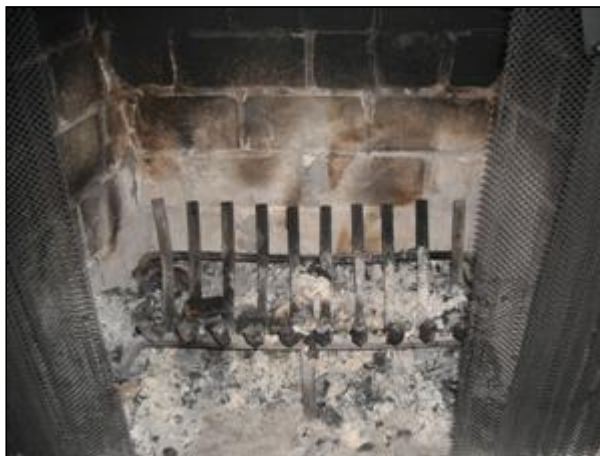
🔧 7.5 The chimney flue was dirty and needs to be cleaned and fully inspected by a qualified contractor before it's first use. Dirty flues are considered a fire hazard.

- 🔧 The chimney flue was dirty and needs to be cleaned and fully inspected by a qualified contractor before it's first use. Dirty flues are considered a fire hazard.

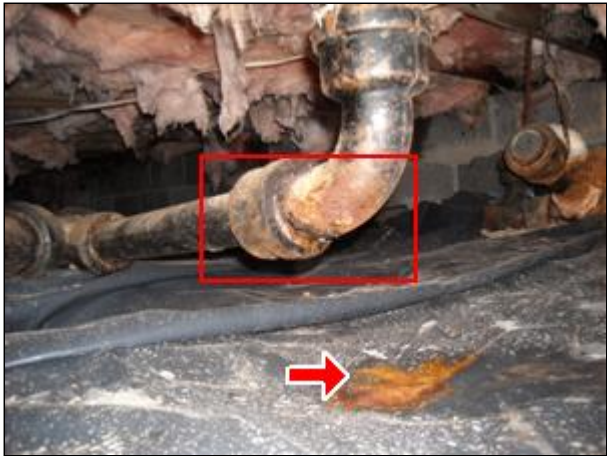
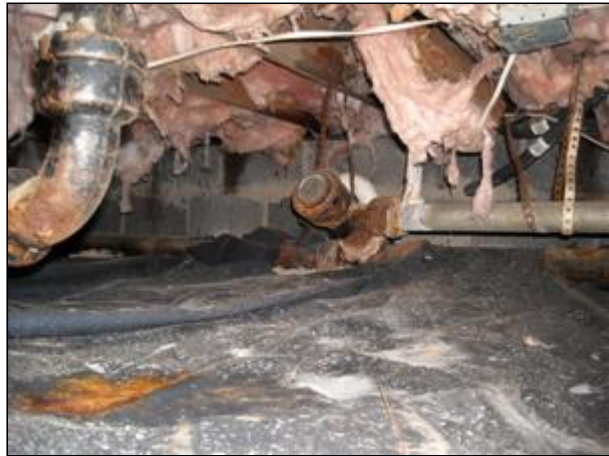
🔧 8.0 The drain, waste, and venting system (DWV) was a combination of cast iron, galvanized, and PVC materials. The cast iron drain lines in the crawlspace were showing signs of deterioration and possible slow leaks. It is common for old cast iron drain lines to deteriorate and leak. Recommend budgeting in the future to install PVC.

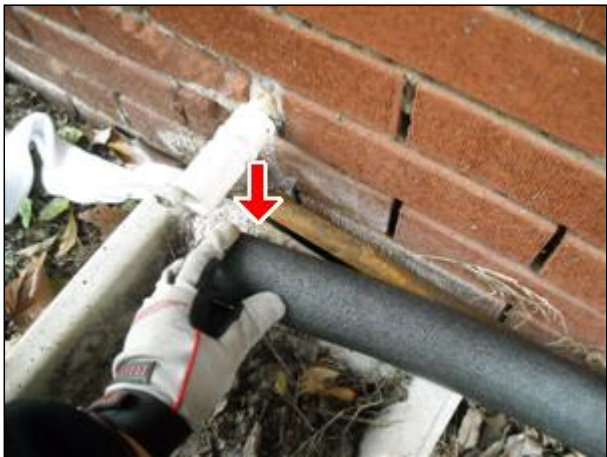
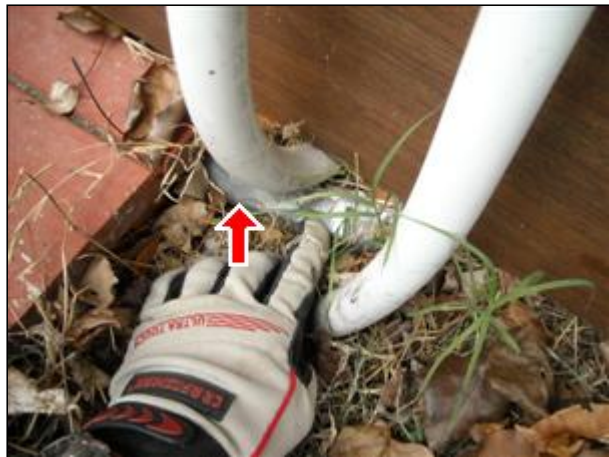
🔧 8.1 I observed what appeared to be a galvanized plumbing supply line on the exterior at the back of the home. Plumbing lines located on the exterior of a home will be prone to freezing.

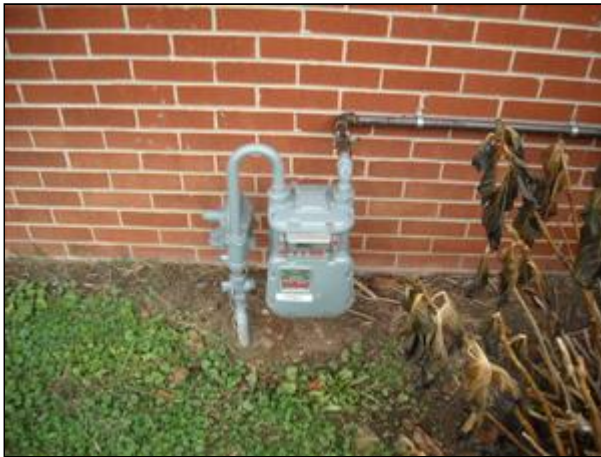
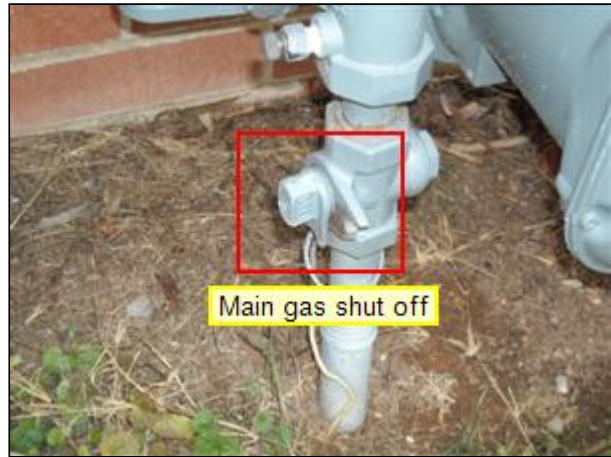
8.5 The main fuel shut off is at gas meter outside.

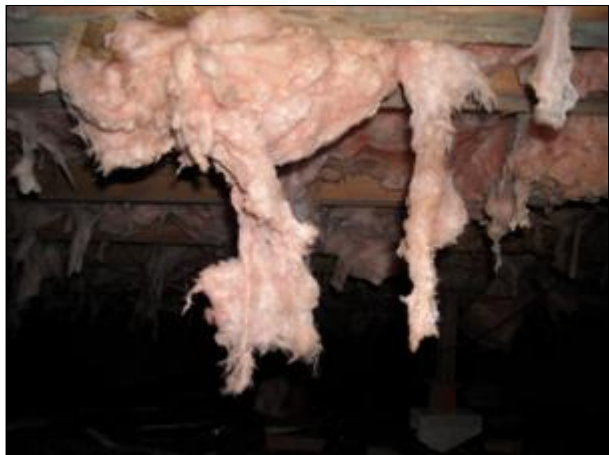
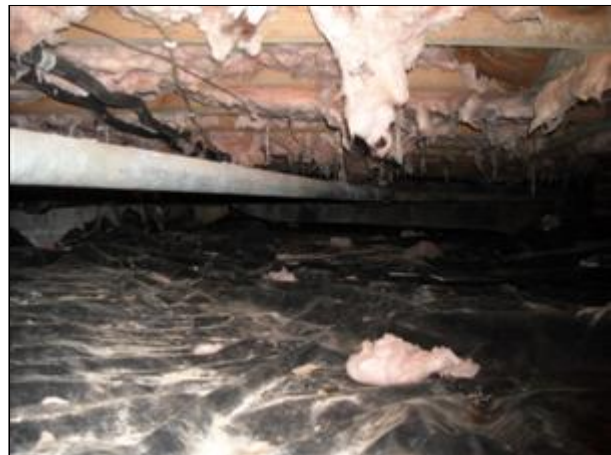
**9.1** The insulation in the crawlspace had a "spider web" effect, which normally indicates moisture due to ground water or inadequate ventilation. At the time of the inspection, the crawlspace appeared to be relatively dry. You should however replace any insulation that can not be put back in to place to prevent heating/cooling loss.

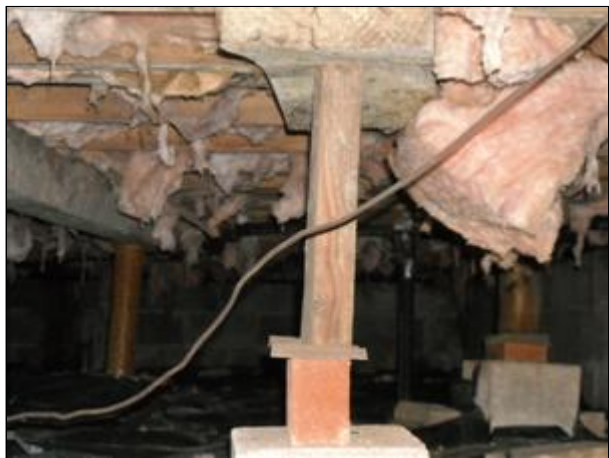
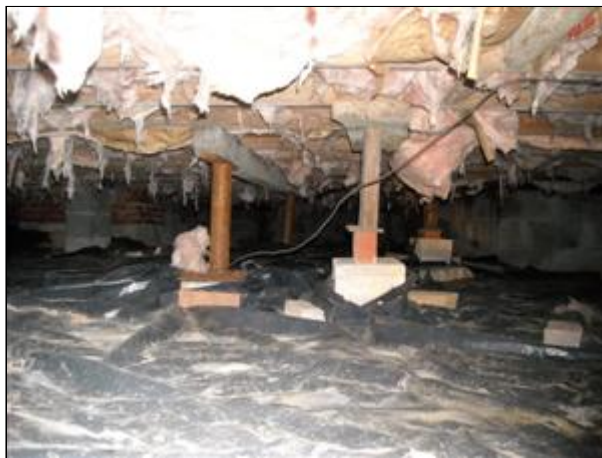
🔧 **10.2** Shoring designed to support sagging floor joists in the crawlspace appeared to have been installed by persons lacking in knowledge of good building practice. Although this shoring may not last as long as professionally-installed shoring, it appeared to be adequately supporting the floor at the time of the inspection. This condition is not uncommon in homes of this age.
