# Property Condition Report

**Property Address:**  
**12345 Commercial Ln**  
**Knoxville TN 37909**

### Commercial Inspection Report

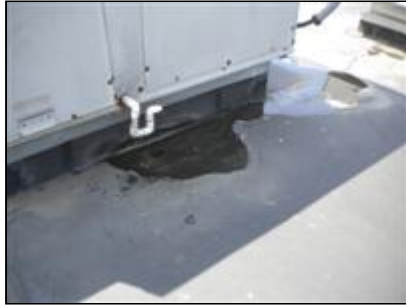
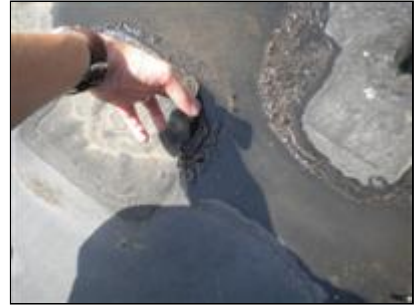
🏠 2.0 (1) The main roof surface is in good condition. Small amounts of ponding was observed on the right side (facing front). It appears the water is coming from the condensate drain at the HVAC unit. Ponding water can and will accelerate the deterioration of roofing materials. Recommend routing the condensate drain to the gutter.

(1) The main roof surface is in good condition. Small amounts of ponding was observed on the right side (facing front). It appears the water is coming from the condensate drain at the HVAC unit. Ponding water can and will accelerate the deterioration of roofing materials. Recommend routing the condensate drain to the gutter.

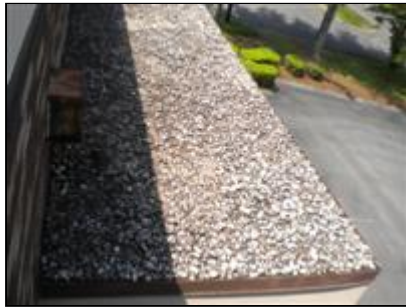
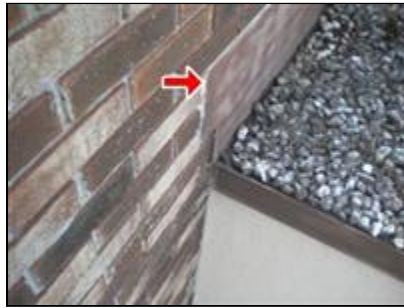
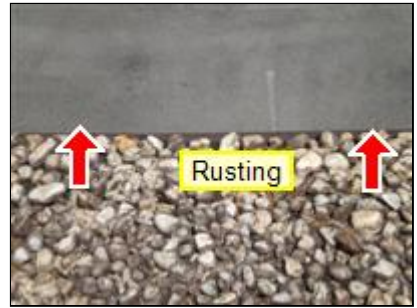
🏠 (2) The awning roof surface appears original to the structure. I did not see any leaks or major deficiencies, but rusting around the outer flashing is causing staining of the front "stucco" surface. Also, additional sealant is needed at the counter flashing against brick.

(2) The awning roof surface appears original to the structure. I did not see any leaks or major deficiencies, but rusting around the outer flashing is causing staining of the front "stucco" surface. Also, additional sealant is needed at the counter flashing against brick.

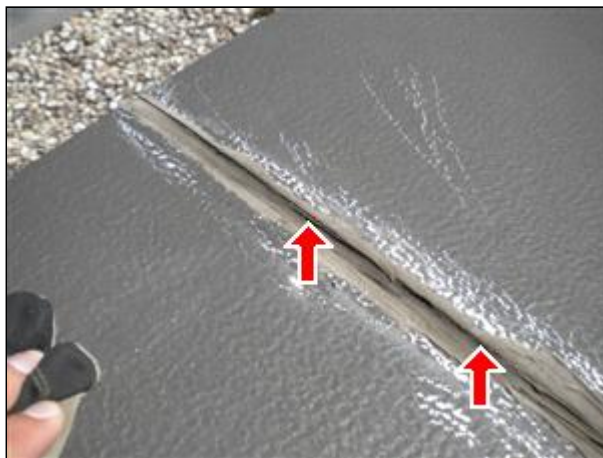
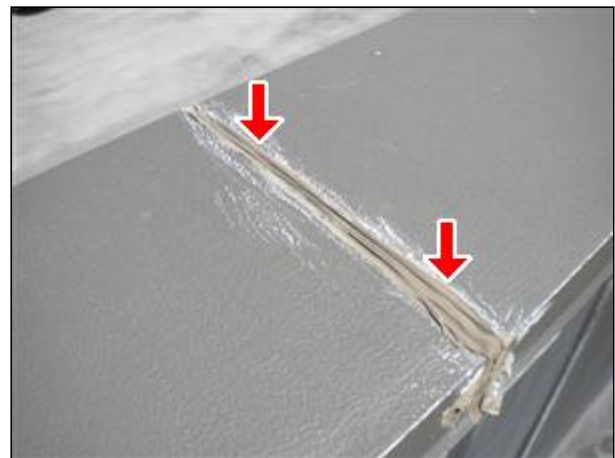
🏠 2.1 Additional sealant is needed at the flashing on top of the parapet wall. It is typical for sealants to dry and shrink.

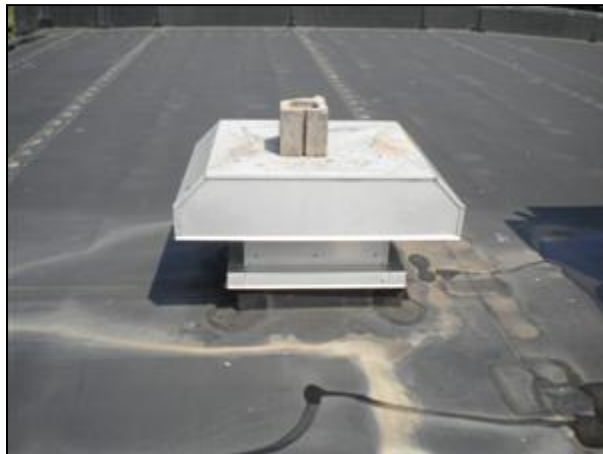
2.2 Item 1(Picture)

**2.2** The interior rooftop access panel is apparently not used anymore. The cover for this access is secured by a cinder block. F.Y.I.

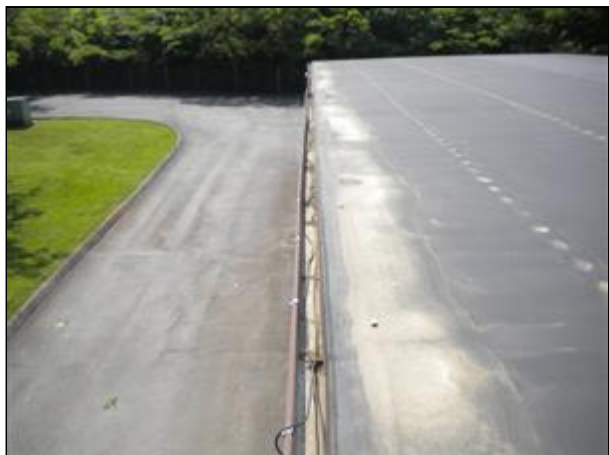
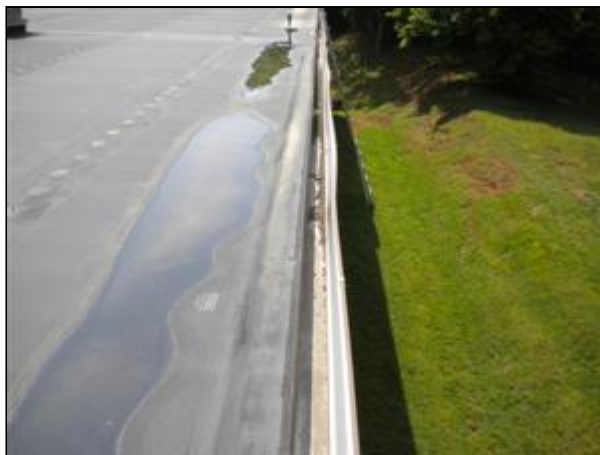
**2.3** The gutters appear to be in good condition. Minor bends/damage was observed, but it does not compromise the functionality/integrity of the drainage systems.

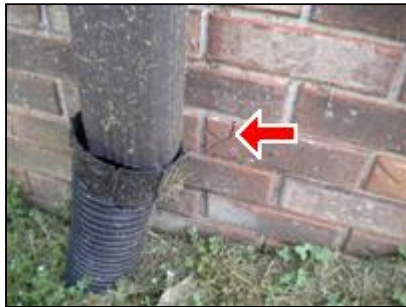
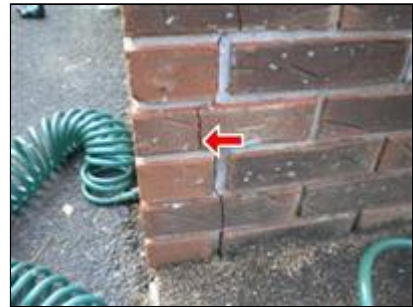
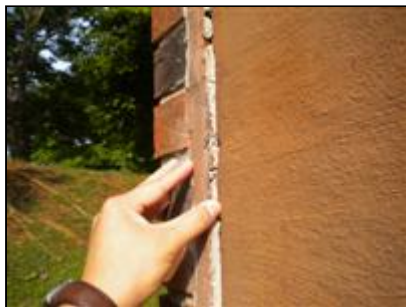
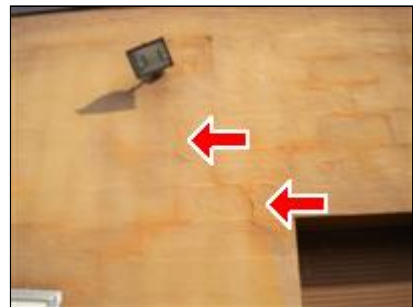
**3.0** The building's exterior is constructed of a brick veneer over concrete block walls at the front, and both sides. The rear of the building is concrete block covered by a parge coat.

- The brick veneer is in good condition with typical cracking primarily due to normal settling. Cracks should be filled to prevent the intake of moisture which can lead to further deterioration.
- The parge coating covering the concrete block wall at the rear of the building is cracking and deteriorating at both ends, along with minor step cracking above openings (doors). It is recommend a qualified general contractor evaluate and repair to prevent further damage.

- The brick veneer is in good condition with typical cracking primarily due to normal settling. Cracks should be filled to prevent the intake of moisture which can lead to further deterioration.
- The parge coating covering the concrete block wall at the rear of the building is cracking and deteriorating at both ends, along with minor step cracking above openings (doors). It is recommend a qualified general contractor evaluate and repair to prevent further damage.

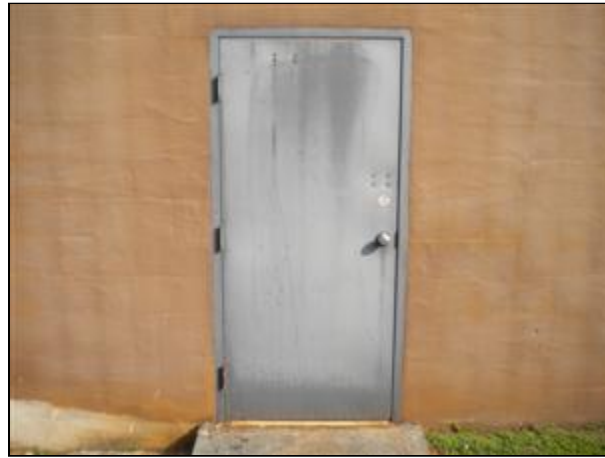
3.1 Item 1(Picture)

**3.1** Both rear steel doors need painting. Painting these doors will prolong their useful life.

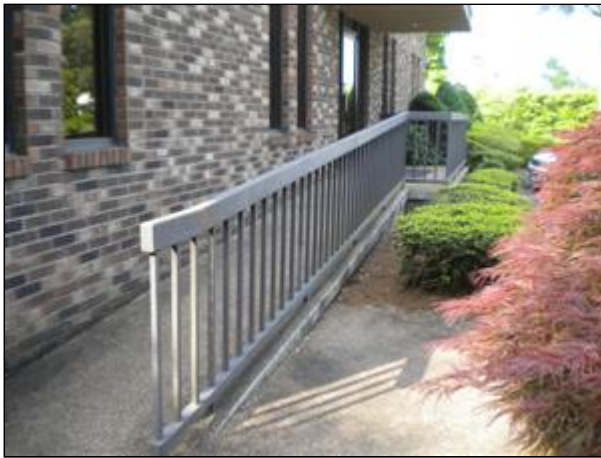
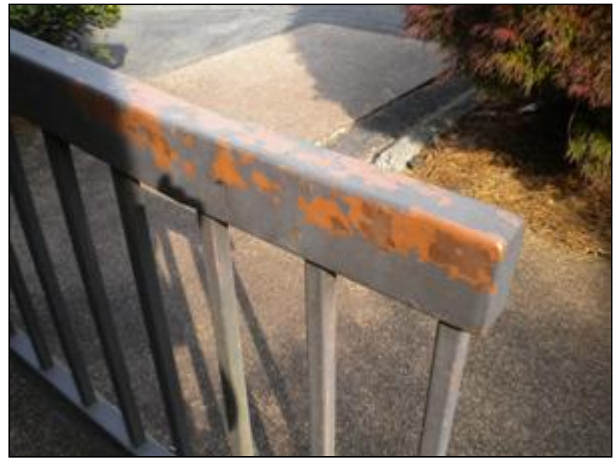
**3.2** The handrailing at the front of the building is intact and appears sturdy, however it is starting to peel paint. Recommend the entire handrail be painted to prolong it's useful life.

The handrailing at the front of the building is intact and appears sturdy, however it is starting to peel paint. Recommend the entire handrail be painted to prolong it's useful life.

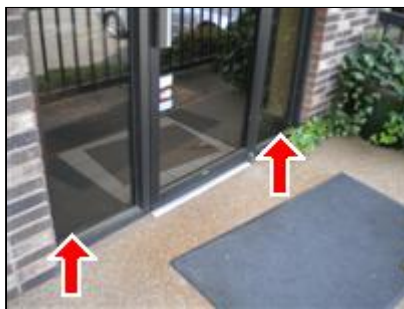
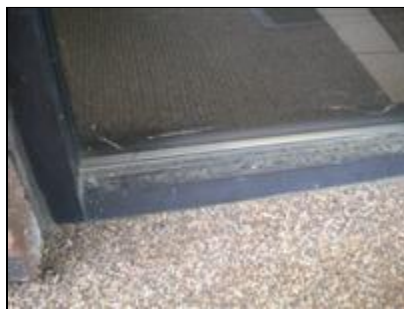
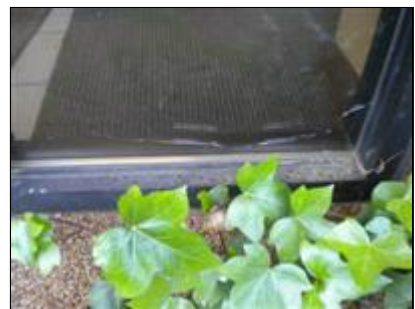
**3.4** Both window panes on either side of the front entry door are cracked along the bottom. Cracking at this location is typically caused by normal foundation settlement that can put a strain on installed doors/glass. I am unable to determine how long this condition has existed.

Both window panes on either side of the front entry door are cracked along the bottom. Cracking at this location is typically caused by normal foundation settlement that can put a strain on installed doors/glass. I am unable to determine how long this condition has existed.

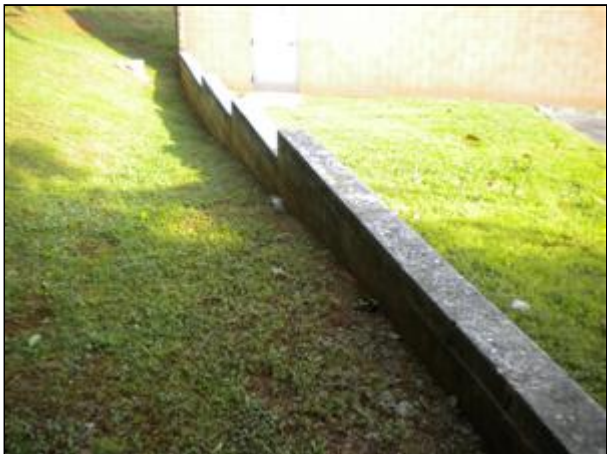
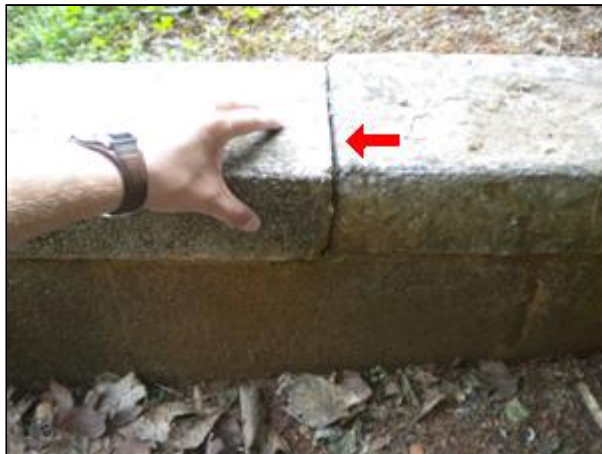
**3.5 (1)** Both designated drain areas at the front of the parking lot were full of debris.

(2) A few loose cinder blocks were observed on the retaining wall at the back of the structure. This is not a significant issue. The wall remains intact and strong at this time.

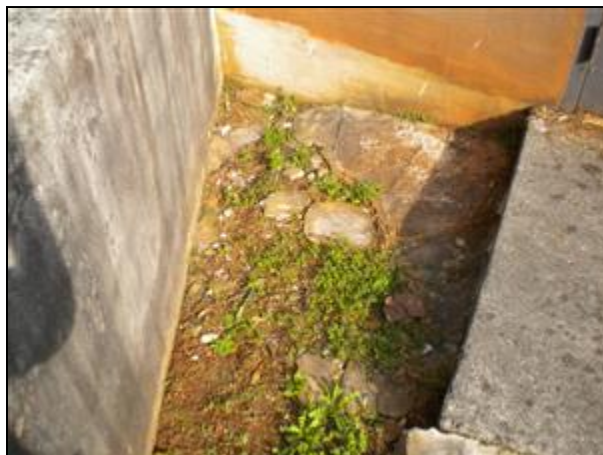
3.5 Item 3(Picture)

🏠 (3) There is a low spot at the left rear corner (facing front) where water may accumulate against the foundation/slab. A drain was previously installed, but has since deteriorated. Recommend repairing drain to divert water away from this area.

(3) There is a low spot at the left rear corner (facing front) where water may accumulate against the foundation/slab. A drain was previously installed, but has since deteriorated. Recommend repairing drain to divert water away from this area.

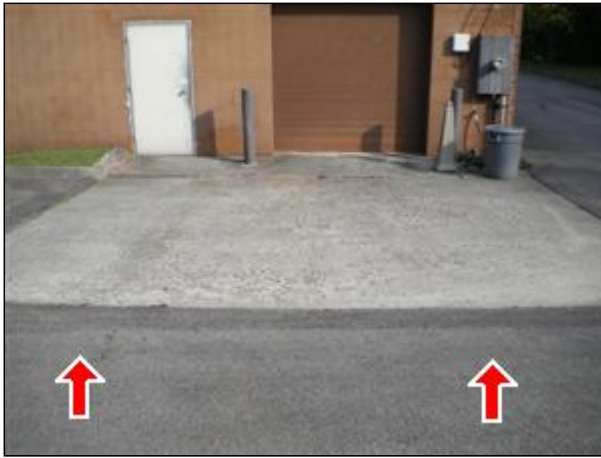
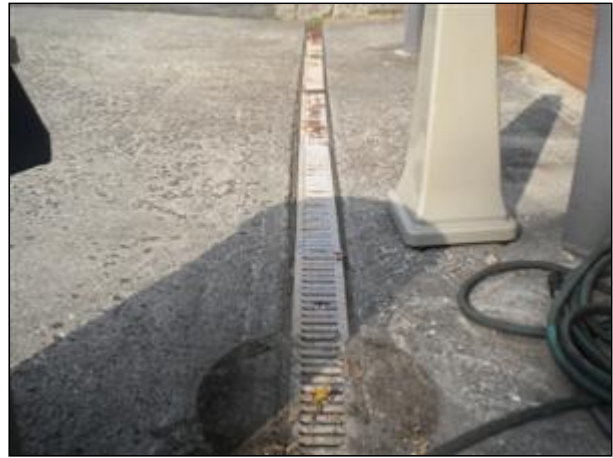
3.6 (1) The general topography of the land does divert water towards the structure at the rear of the building. Systems have been put in place to control water runoff such as the drain installed at the rear service door, along with the retaining wall and attached drain.

General maintenance and upkeep will be crucial in preventing the intake of moisture at these areas.

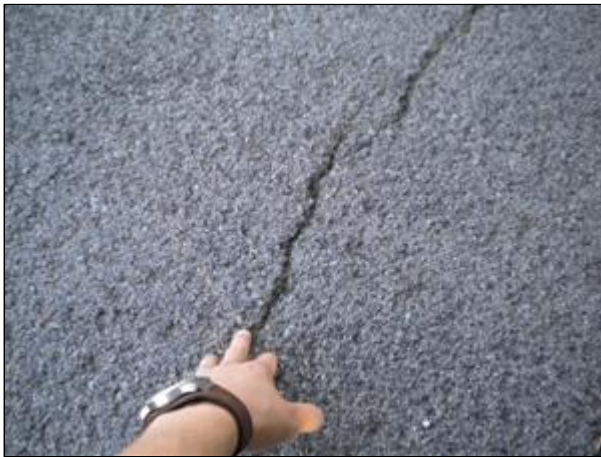
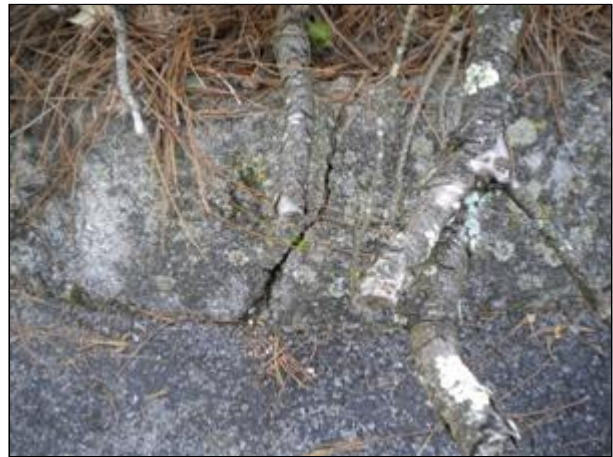
(2) The asphalt parking lot is in excellent condition with minor cracking/pitting observed. As cracks develop, it is recommend they be sealed to prevent the intake of moisture which can lead to further deterioration.

The striping was faded and may need repainting in the near future.

The curbing around the parking lot has minor cracking, but does not appear significant at this time.

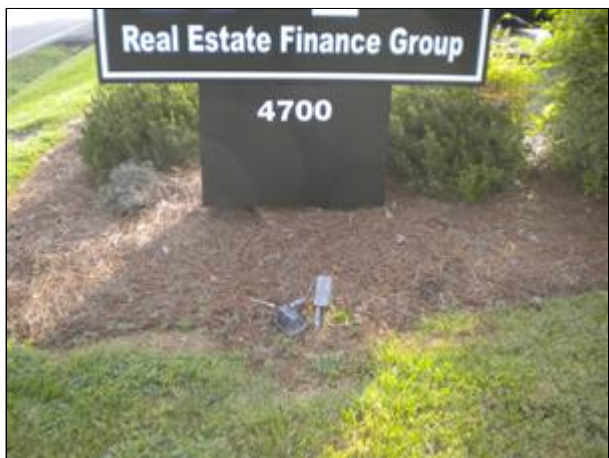
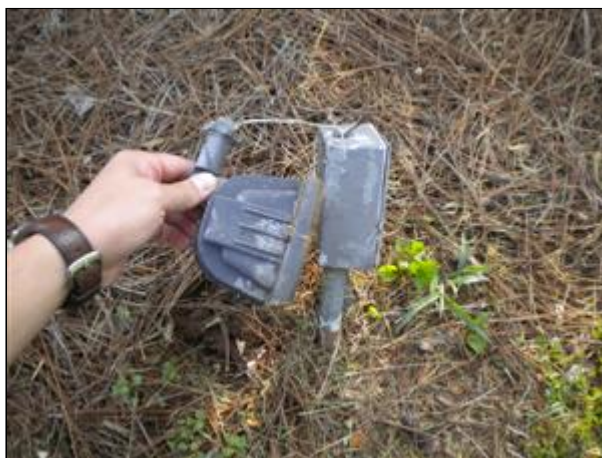
**3.7** (1) The overall condition of the exterior lighting was acceptable, however a few issues were observed.

- The bulb was burnt out at the rear parking lot light. It appears a replacement bulb is all that is needed.
- Both landscaping lights directed towards the company sign at the front of the building appear damaged beyond repair and will likely need replacement.

(1) The overall condition of the exterior lighting was acceptable, however a few issues were observed.

- The bulb was burnt out at the rear parking lot light. It appears a replacement bulb is all that is needed.
- Both landscaping lights directed towards the company sign at the front of the building appear damaged beyond repair and will likely need replacement.

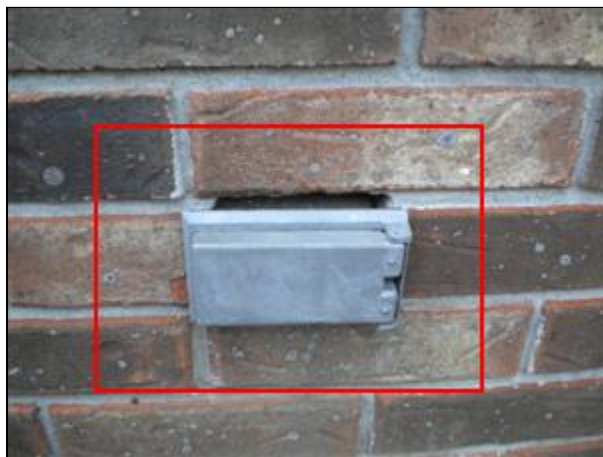
3.7 Item 3(Picture)

**3.7** (2) There is a gap between the exterior GFCI outlet and the brick veneer at the front of the building. Recommend sealing gap with an appropriate sealant to prevent the intake of moisture.

(2) There is a gap between the exterior GFCI outlet and the brick veneer at the front of the building. Recommend sealing gap with an appropriate sealant to prevent the intake of moisture.

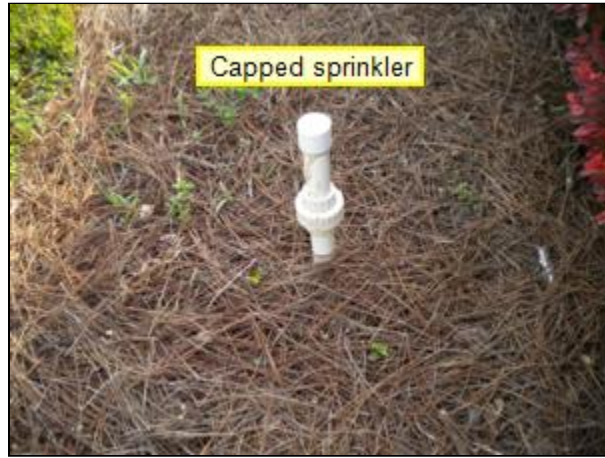
3.9 Item 1(Picture)

3.9 The sprinkler system has been discontinued/capped. F.Y.I.

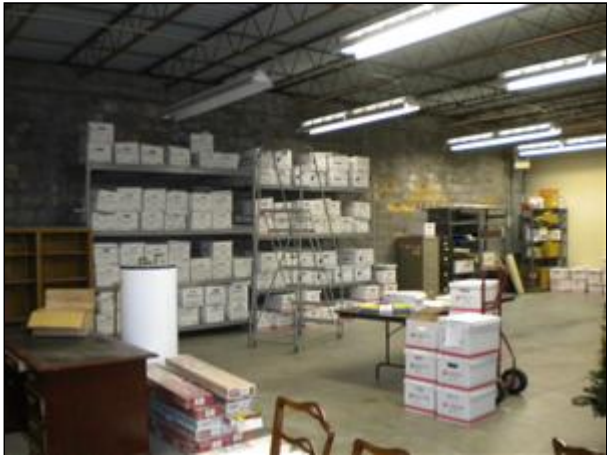
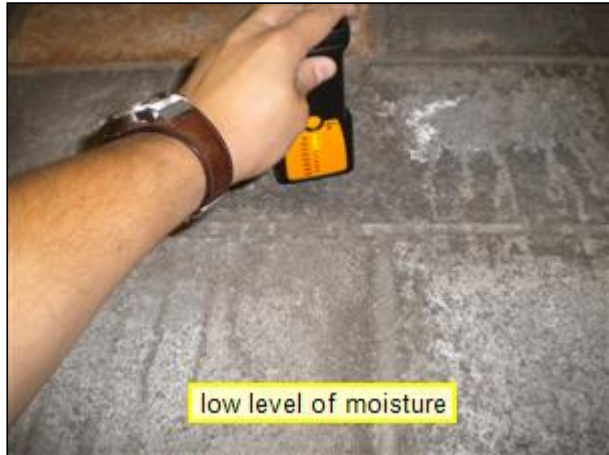
**4.0** Large amount of staining/efflorescence was observed on the right (facing front) block wall in the warehouse area. Different locations were tested with a moisture meter and no elevated levels were found at the time of the inspection.

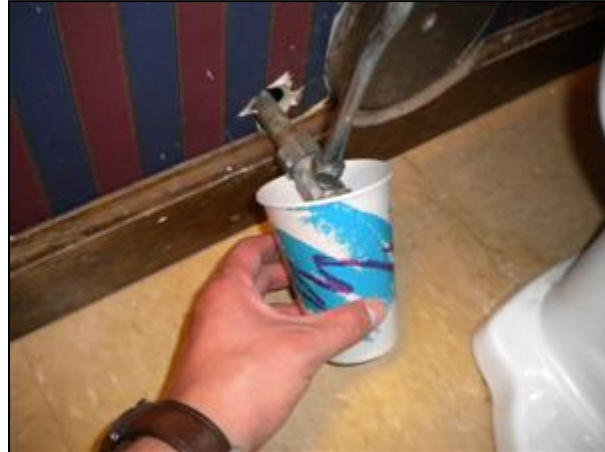
5.1 Item 1(Picture)

- 🏠 5.1 There is a small leak at the shutoff for the toilet in the men's bathroom. Recommend replacing the shutoff.

There is a small leak at the shutoff for the toilet in the men's bathroom. Recommend replacing the shutoff.

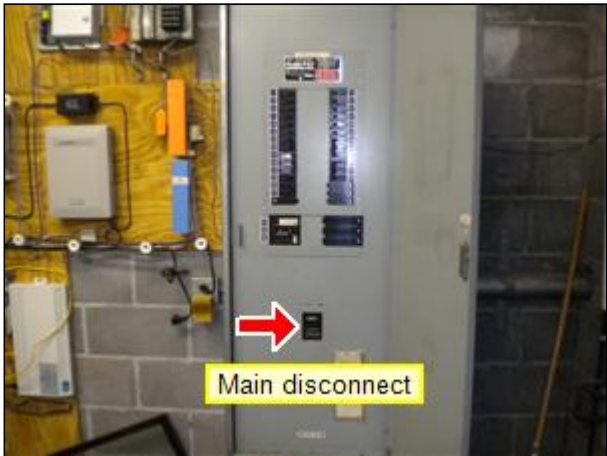
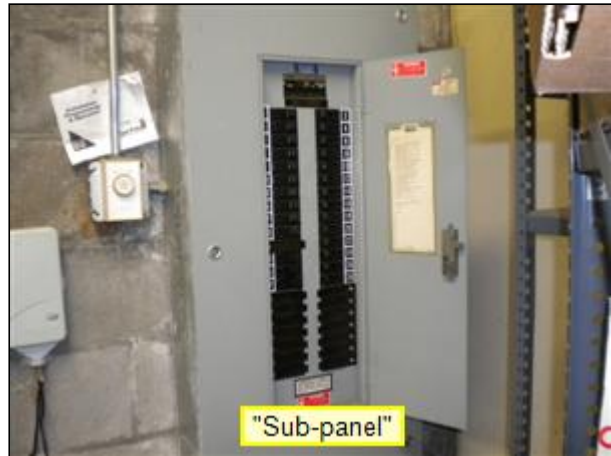
**6.1** The main service panel and "sub-panel" are manufactured by Federal Pacific. Federal Pacific is no longer in business due to a line of faulty panels made for residential use called the "Stab-Loc" line. Parts or breakers may be hard to find for replacement or addition purposes.

**6.2** The main service panel is located at the right exterior wall (facing front) in the warehouse area. The "sub-panel" is located on the right exterior wall (facing front) in the warehouse area.

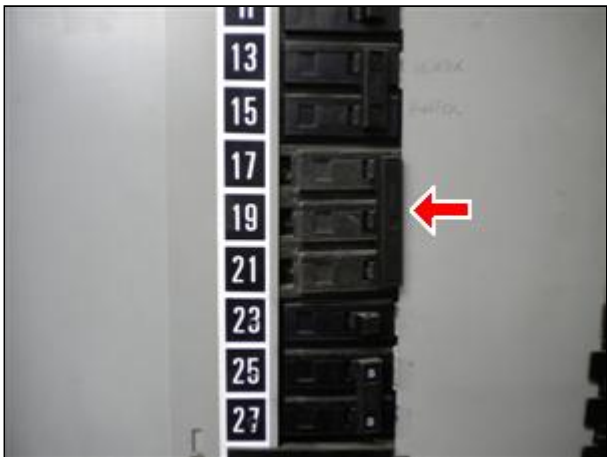
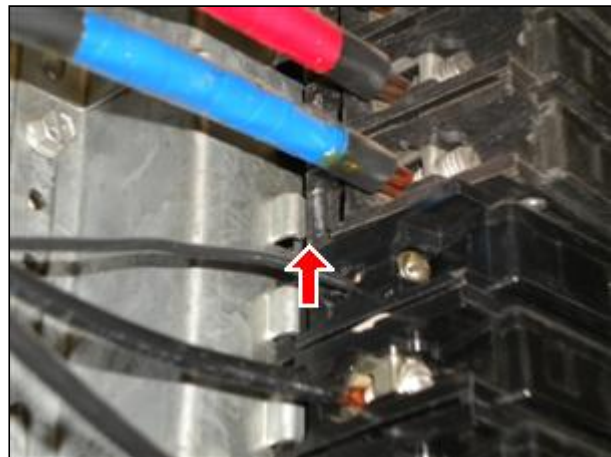
**6.3** The breaker feeding the "sub-panel" at the service main is loose and not fully attached to the bus bar. This is a safety concern due to the potential for electrocution. Recommend an electrician evaluate and repair as necessary.

The breaker feeding the "sub-panel" at the service main is loose and not fully attached to the bus bar. This is a safety concern due to the potential for electrocution. Recommend an electrician evaluate and repair as necessary.

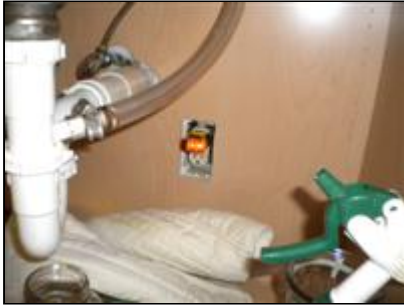
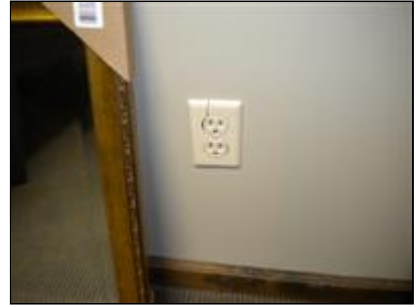
**6.4** A representative number of outlets, lights, and other fixtures were observed and/or operated. The general and overall condition was acceptable, however a few outlets have broken and/or missing covers, and a handful of fluorescent bulbs need replacement.

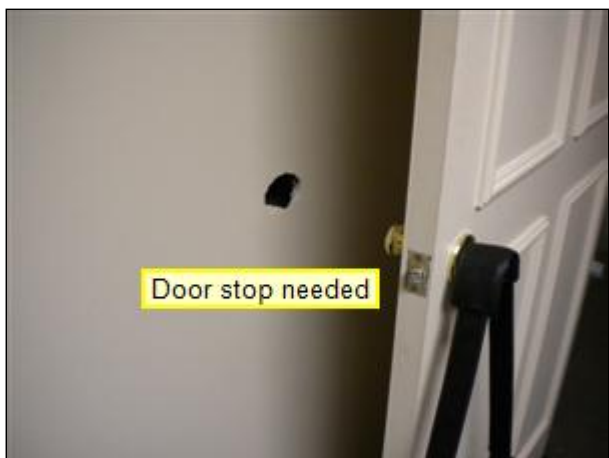
7.1 Item 1(Picture)

🏠 7.1 Minor patching and painting will need to be done throughout the office area. Two of the larger holes are located in the back right corner office (facing front) and the front left corner office (facing front).

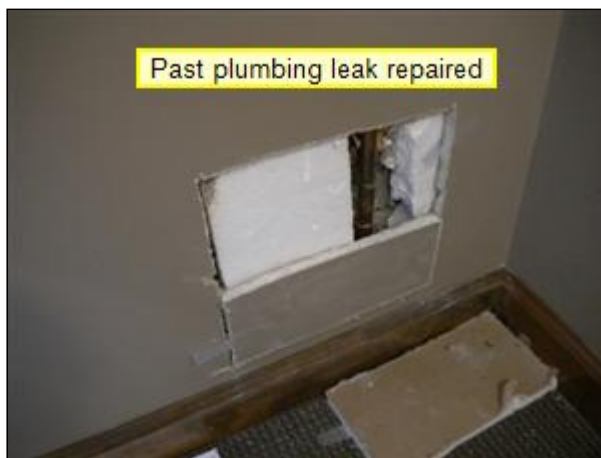
7.1 Item 2(Picture)

Picture #2 shows an area where the current owners state a plumbing pipe froze and was repaired. No leaks were present and the repair appears adequate. F.Y.I.

*Picture #2 shows an area where the current owners state a plumbing pipe froze and was repaired. No leaks were present and the repair appears adequate. F.Y.I.*

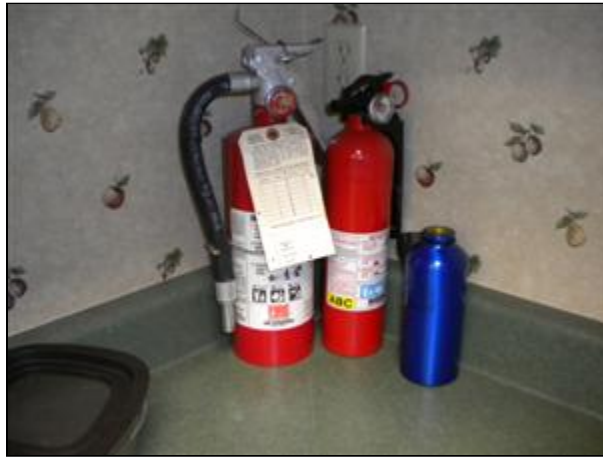
8.7 Item 1(Picture)

8.7 Located in the kitchen area.

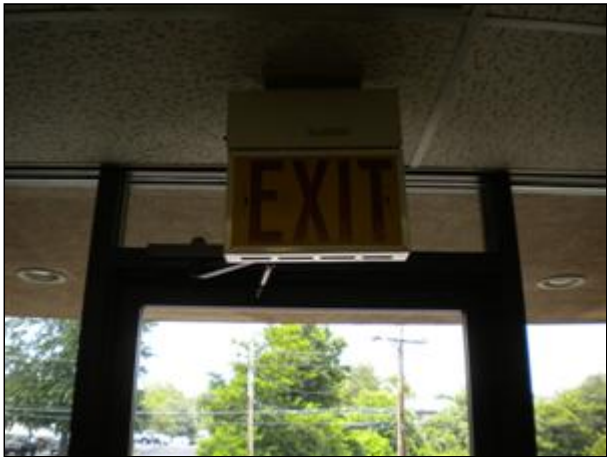
8.9 Item 1(Picture)

8.9 Exit signs located throughout building.

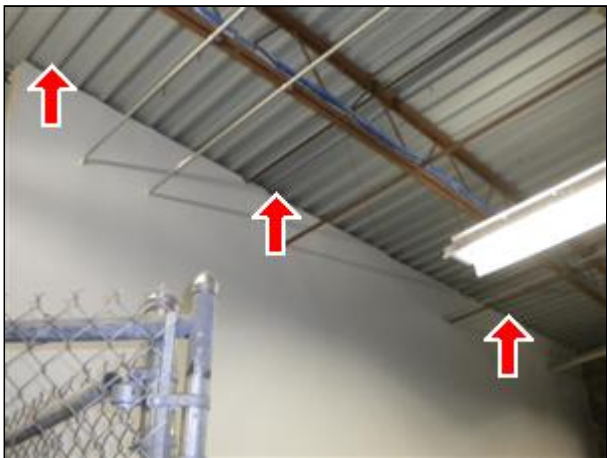
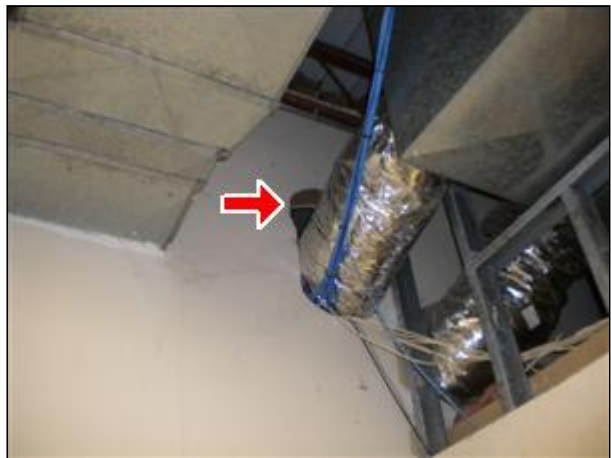
8.11 Numerous unsealed openings in the wall separating the storage facility from the office area were observed. All openings should be filled with an appropriate sealant.

Numerous unsealed openings in the wall separating the storage facility from the office area were observed. All openings should be filled with an appropriate sealant.

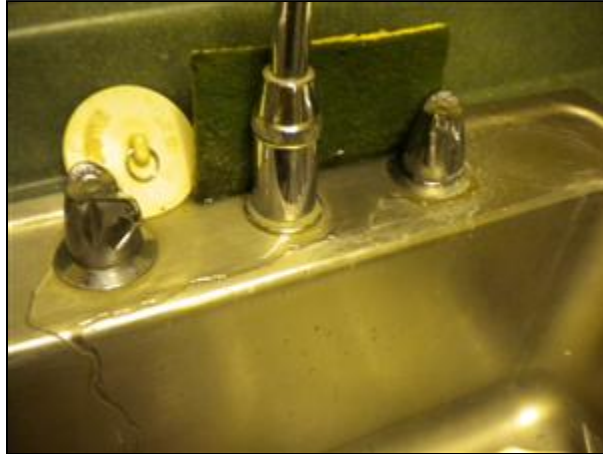
9.8 Item 1(Picture)

**9.8** The kitchen sink faucet leaks heavily at the base. This typically indicates a seal has gone bad. Recommend replacement of the seal, or the entire faucet assembly.

The kitchen sink faucet leaks heavily at the base. This typically indicates a seal has gone bad. Recommend replacement of the seal, or the entire faucet assembly.
